EXHIBIT B

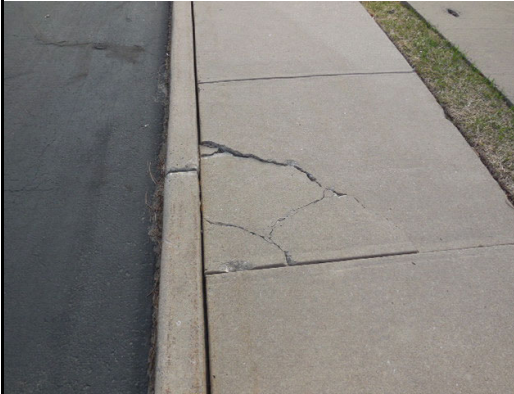
ALTERNATE NUMBER	DESCRIPTION	IMAGE
1	SIDEWALK REPAIR LOT D PREFERRED

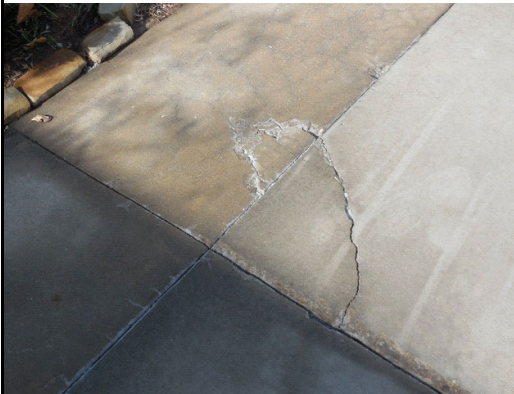
2	SIDEWALK REPAIR AT CU ENTRY 1

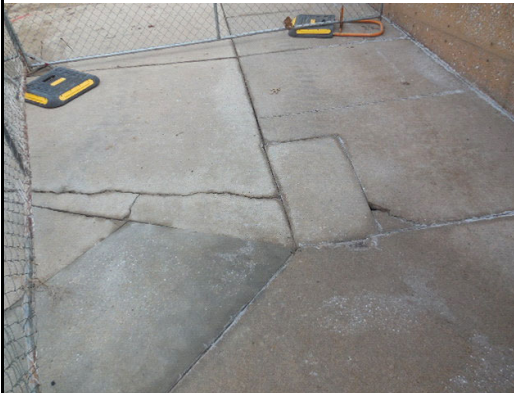
3	SIDEWALK REPAIR LOT C TO AH ENTRY 2

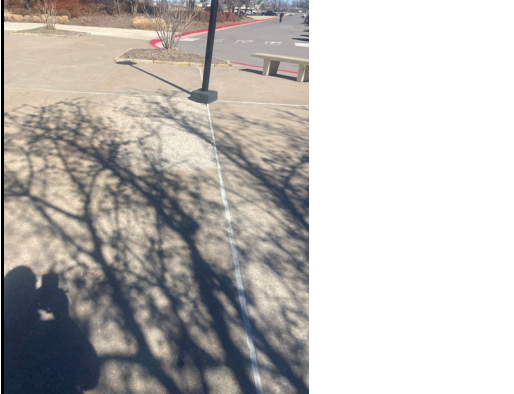
4	CONCRETE REPAIR LIBRARY PLAZA

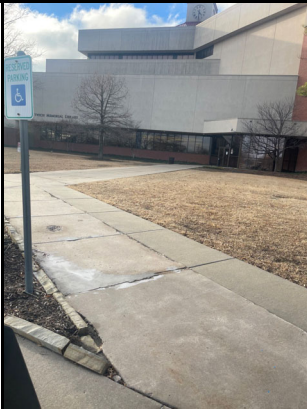
ALTERNATE NUMBER	DESCRIPTION	IMAGE
5	SIDEWALK REPAIR NEAR LIBRARY ENTRY 2

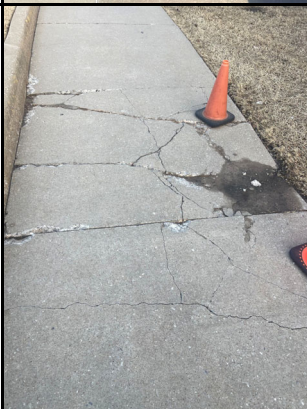
A photograph showing a sidewalk repair area. The repair is a rectangular patch of lighter-colored concrete. In the background, there is a building with a glass facade. A black trash can is visible in the foreground on the right side of the sidewalk.
7	SIDEWALK REPAIR SEM ENTRY 7

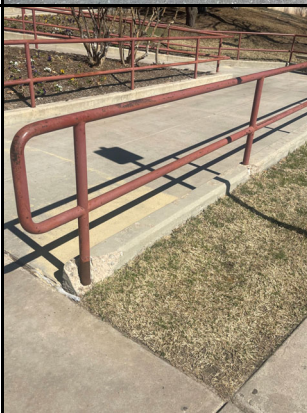
A photograph showing a sidewalk repair area. The repair is a rectangular patch of lighter-colored concrete. An orange traffic cone is visible in the foreground on the right side of the sidewalk.
8	CURBING REPAIR SEM ENTRY 5

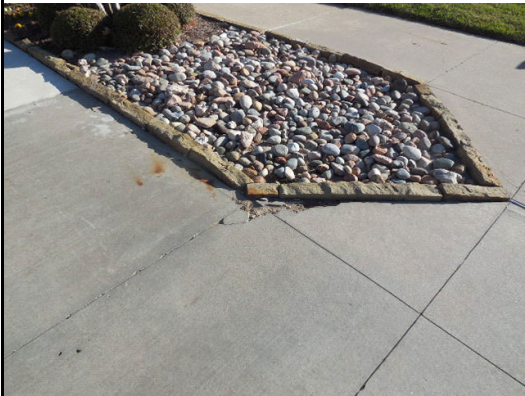
ALTERNATE NUMBER	DESCRIPTION	IMAGE
9	SIDEWALK REPAIR MB ENTRY 3

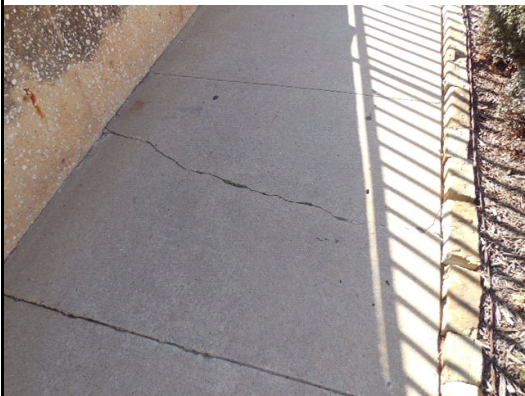
A photograph showing a concrete sidewalk repair. The repair area is a rectangular patch of concrete, bordered by a decorative border of light-colored, rounded stones. The surrounding sidewalk is made of larger concrete slabs.
10	SIDEWALK REPAIR MB ENTRY 3

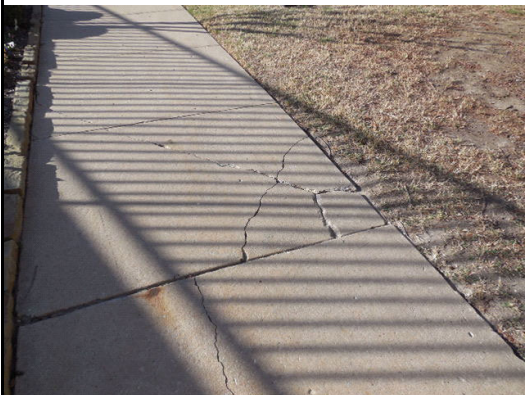
A photograph showing a concrete sidewalk repair. The repair area is a rectangular patch of concrete, bordered by a metal grate. The surrounding sidewalk is made of larger concrete slabs.
11	SIDEWALK REPAIR MB ENTRY 3

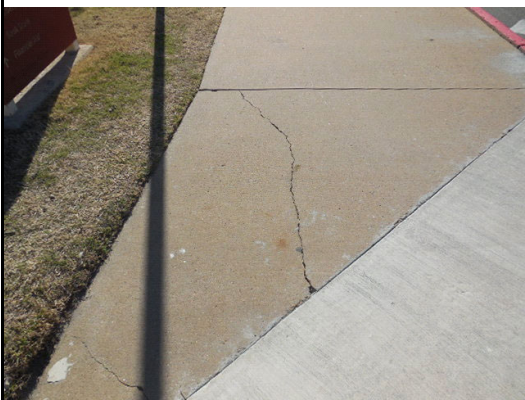
A photograph showing a concrete sidewalk repair. The repair area is a rectangular patch of concrete, bordered by a metal grate. The surrounding sidewalk is made of larger concrete slabs.
12	SIDEWALK REPAIR MB ENTRY 3

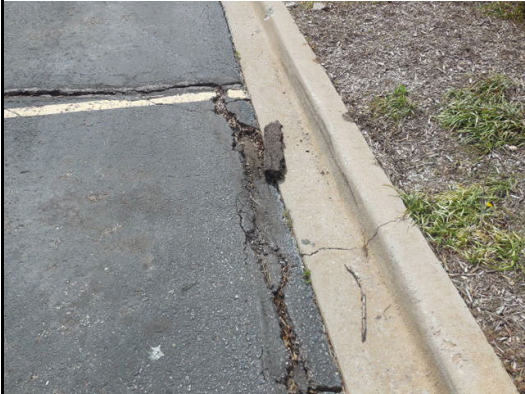
ALTERNATE NUMBER	DESCRIPTION	IMAGE
21	ASPHALT REPAIR PARKING LOT A SOUTH

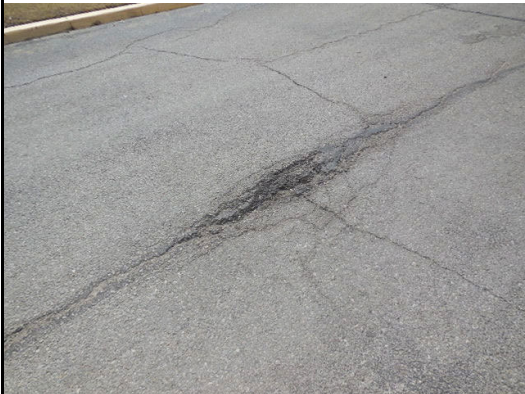
A close-up photograph showing a section of asphalt pavement adjacent to a concrete curb. The asphalt surface is dark grey and appears to be a repair area, with some loose material and a crack visible along the edge of the curb. The curb is light-colored concrete.
22	ASPHALT REPAIR PARKING LOT A

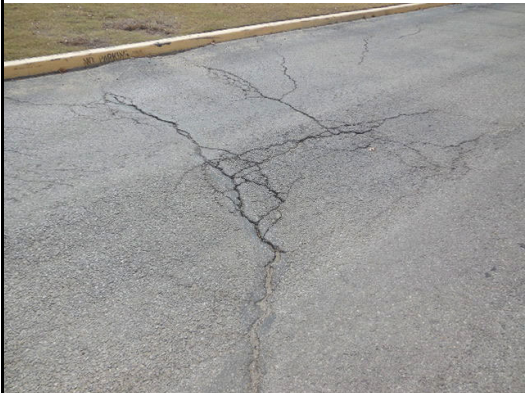
A photograph of a wide asphalt surface in a parking lot. The asphalt is light grey and shows several prominent, dark, irregular cracks that run across the surface. The cracks are most visible in the center and right side of the frame.
23	ASPHALT REPAIR PARKING LOT A

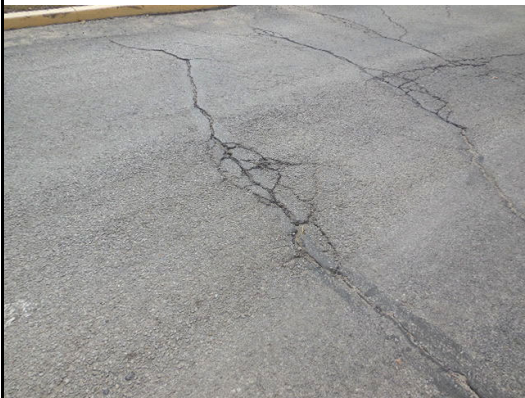
A photograph of an asphalt surface in a parking lot, similar to the previous image. It shows a network of dark, irregular cracks on a light grey asphalt surface. A concrete curb is visible in the upper left corner of the frame.
24	ASPHALT REPAIR PARKING LOT A

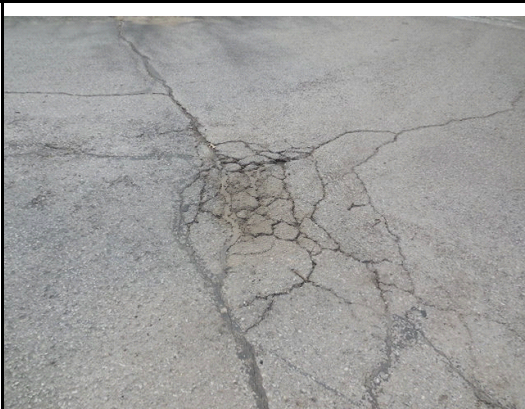
ALTERNATE NUMBER	DESCRIPTION	IMAGE
25	ASPHALT REPAIR PARKING LOT A

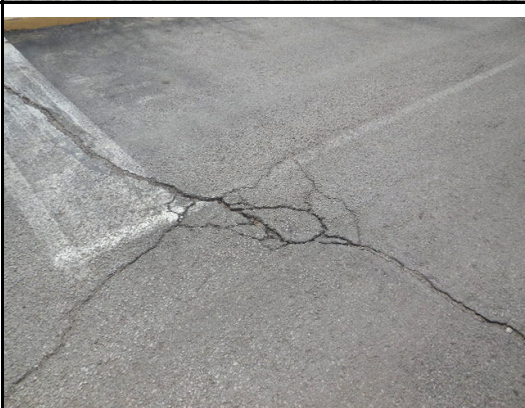
26	ASPHALT REPAIR PARKING LOT A

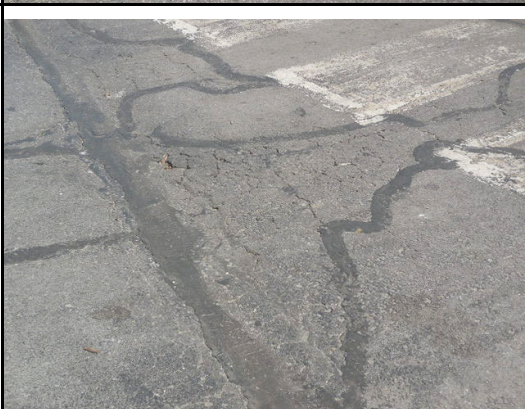
27	ASPHALT REPAIR REGENTS LOOP BY MB ENTRY 2

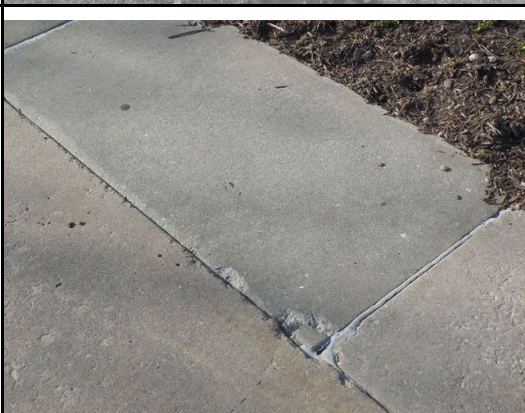
28	CONCRETE REPAIR BY CU 1 (2 SPOTS MIRRORED ON SIDEWALK)
