EXHIBIT B

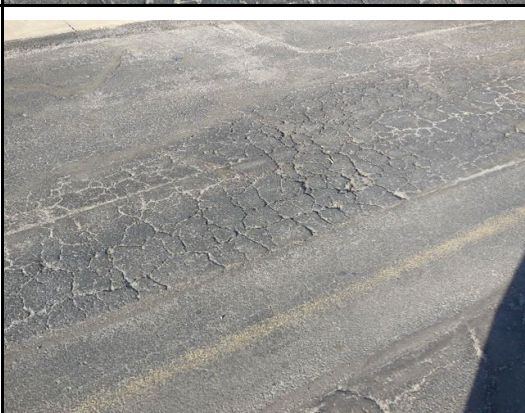
ALTERNATE NUMBER	DESCRIPTION	IMAGE
17	SIDEWALK REPAIR WC ENTRY 2	 
18	SIDEWALK REPAIR LOOP ROAD BY POND OVERFLOW	 
19	ASPHALT DRIVE REPAIR CPD	 
20	ASPHALT DRIVE REPAIR CPD
